Building and Pest Inspection

Safeguard Inspections

1 Sample Lane, Brisbane, QLD, 4000

Pest And Building Inspection

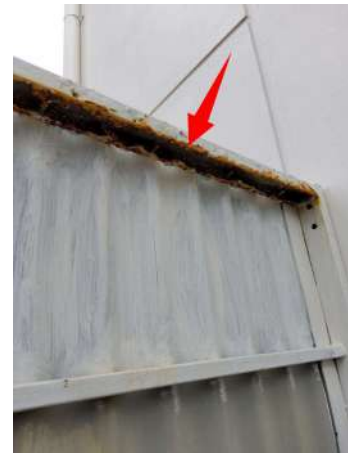
Overall Condition

General age to fence components - Recommendations:
General upkeep and maintenance. A qualified fencing contractor should be engaged for repairs
Rust Noted To Gates. Replacement Recommended.

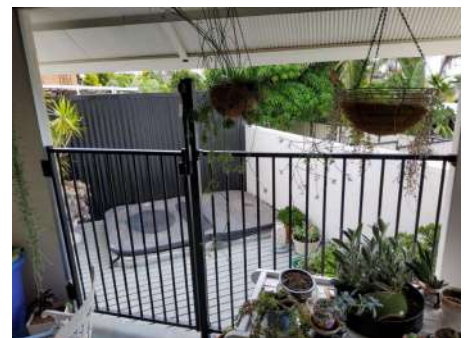
Pool Fence

A swimming pool is present but the pool fence appears inadequate. The pool fence should be checked for compliance with safety regulations. Considered a Safety Hazard
The appropriate warning signs do not appear to be present. You should check with your local council regarding the required signs.

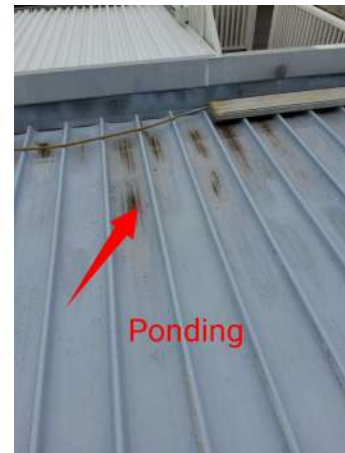
Roof Clad Condition

Metal roof is rusting and requires repairs to prevent further deterioration. Ponding was also noted in sections of the roof sheeting. Contact a licensed roofing contractor for further investigation.

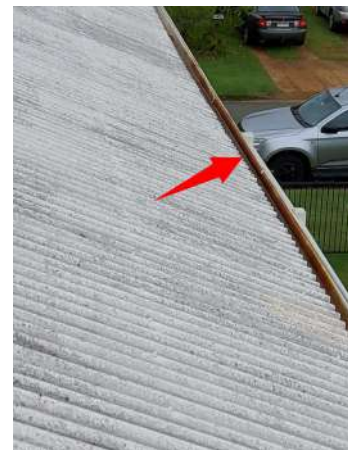
Gutter Findings

Gutter surface rust in sections- the rust is yet to penetrate and repairs/sealing may be an option. Recommendations: A qualified roof plumber should be engaged for advice and recommendations.

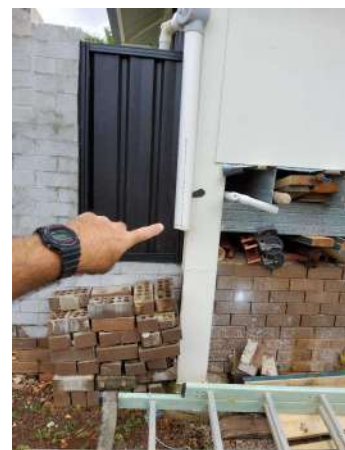
Down Pipe Findings

Down pipe/s not connected to storm water discharge - Down pipes not connected to storm water have the potential to cause differential settlement to the footings, cause rising damp and is also conducive to termite infestation. Recommendations: A qualified plumber should be engaged for advice and recommendations.

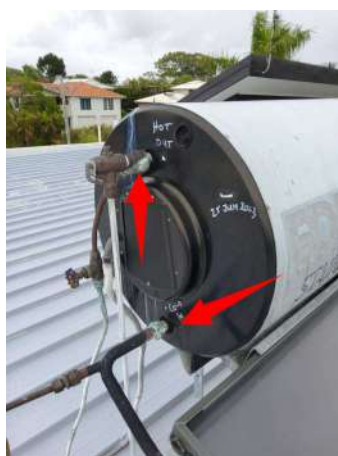
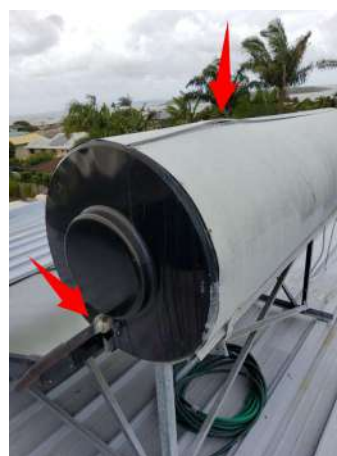
Hot Water Unit Findings

On visual inspection the hot water unit appears dilapidated. Anticipate a replacement in the not too distant future.

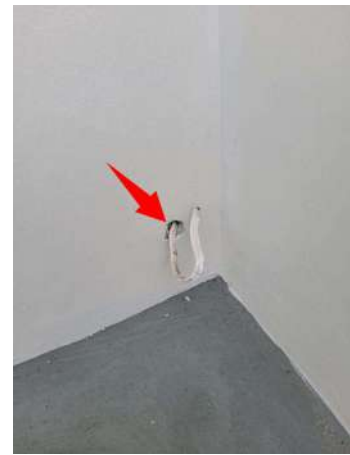
Condition

Penetration openings observed. I recommend sealing these off so as to avoid water, vermin and other pest infestation.

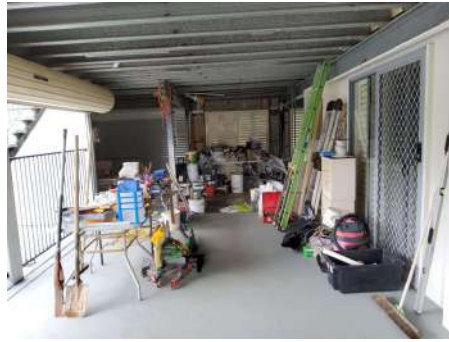
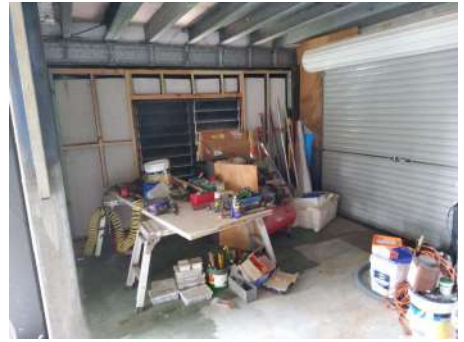
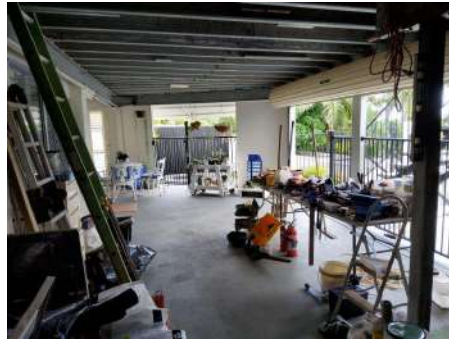
Overall Condition

Defects exist to an area or component/s requiring assessment by a specialised field. Please read below for details. Incomplete building work noted, contact a builder for rectifications.

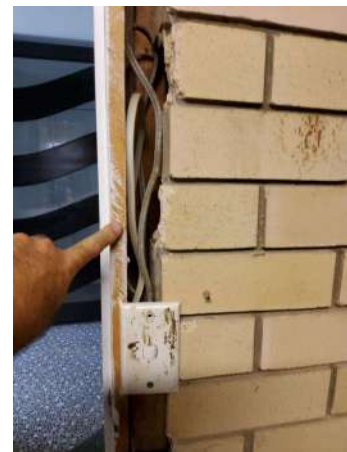
Wall Cladding Findings

Exposed electrical cables noted. Contact a licensed electrician for repairs immediately.

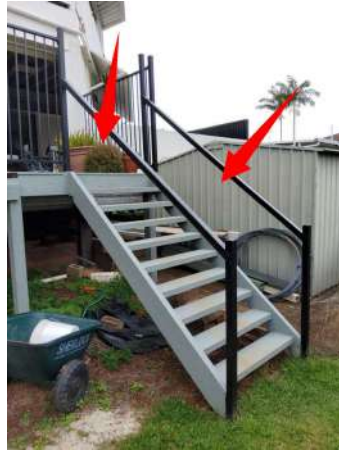
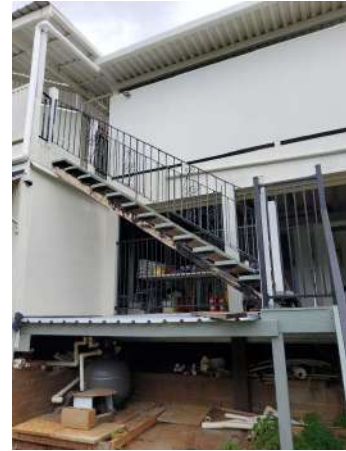
Balustrade and Rails

There are no rails on a flight of stairs leading to the house. This presents a fall risk. Have repaired immediately.

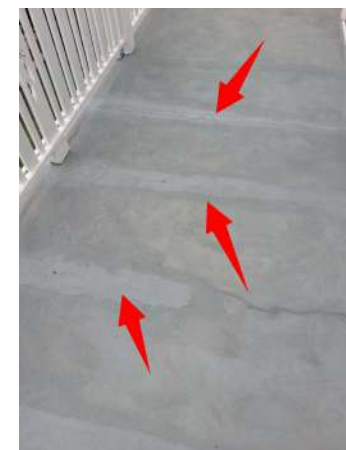
Flooring

The floor sheeting has cracks, contact a licensed builder or waterproofing specialist for repairs.

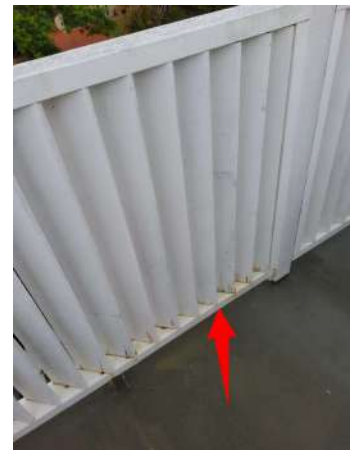
Balustrade Condition

General age deterioration to balustrade and/or posts/rails.
Recommendations: Have assessed by a carpenter.

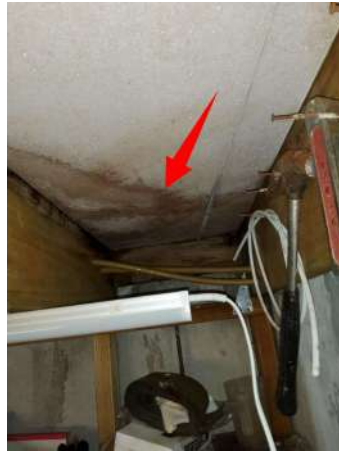
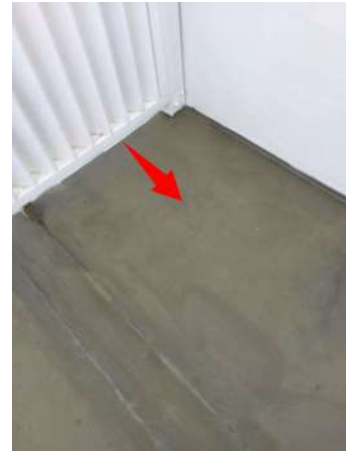
Visible Floor Base Leaking

Leaking has occurred through flooring. Recommendations: A qualified builder should be engaged for advice and recommendations. Balcony leaking is one of the largest complaints received by the building commission and rectification can involve removing all flooring and adequate damp proofing works carried out.

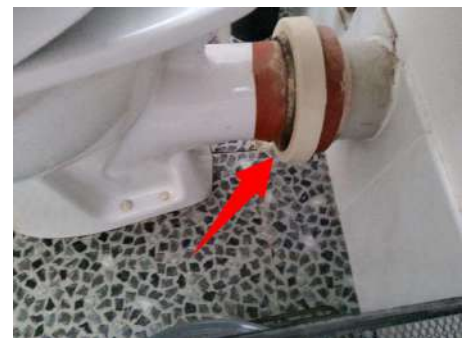
Toilet

The seal is deteriorated where leaking can occur. Contact a licensed plumber for replacement.

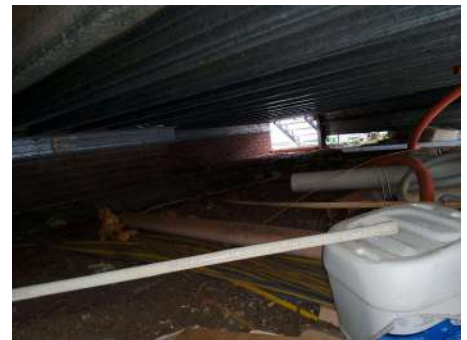
Piers And Foundation Walls

Rust is evident in the post / posts supporting the house. This must be treated to prevent further deterioration of materials.
