Building and Pest Inspection

Safeguard Inspections

1 Sample Lane, Brisbane, QLD, 4000

Pest And Building Inspection

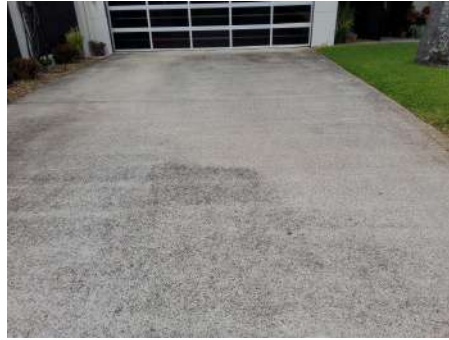
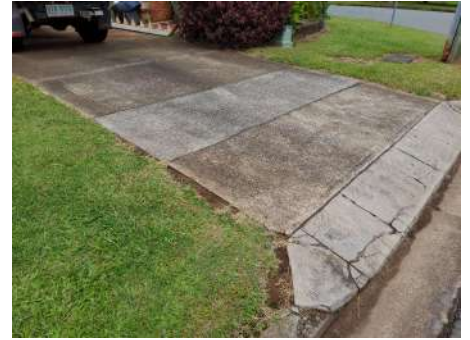
Driveway Condition

On visual inspection, the general condition of the driveway is in a serviceable condition.

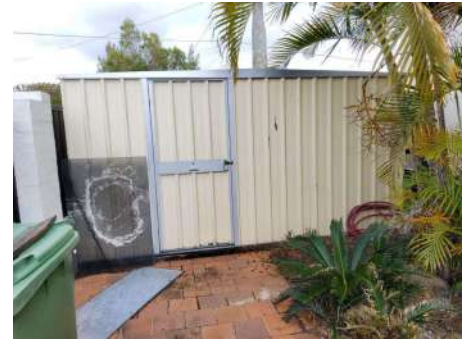
The shed is in fair usable condition.

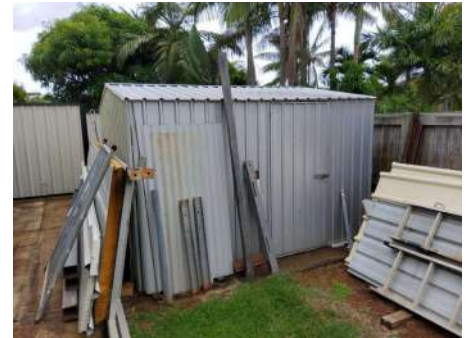
Shed(2)

The shed is in fair usable condition.

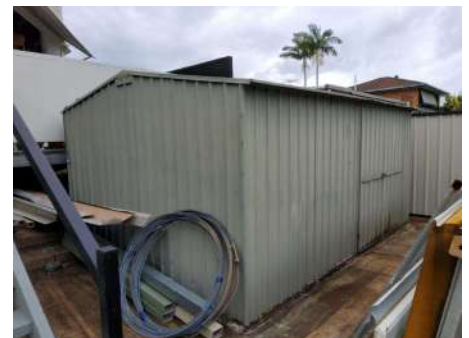
Shed(3)

The shed is in fair usable condition.

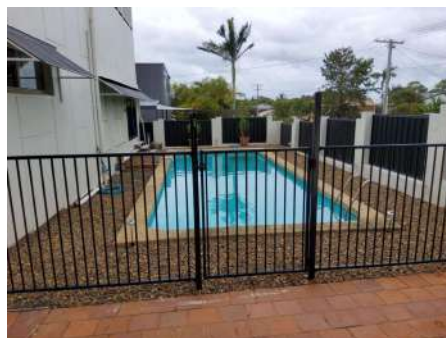
Pool Fence

A swimming pool is present but the pool fence appears inadequate. The pool fence should be checked for compliance with safety regulations. Considered a Safety Hazard
The appropriate warning signs do not appear to be present. You should check with your local council regarding the required signs.

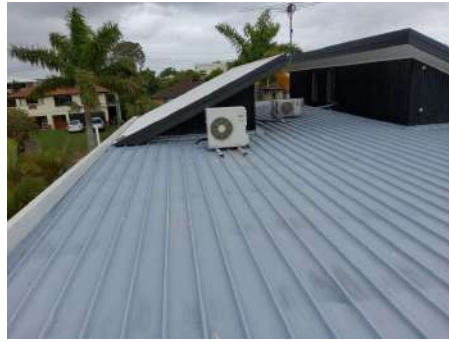
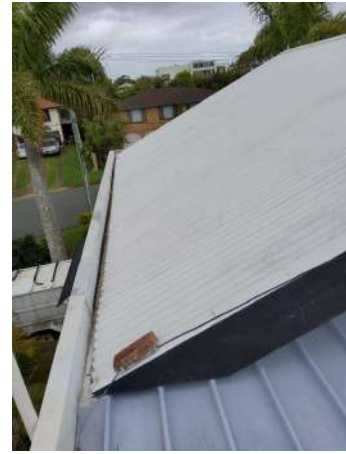
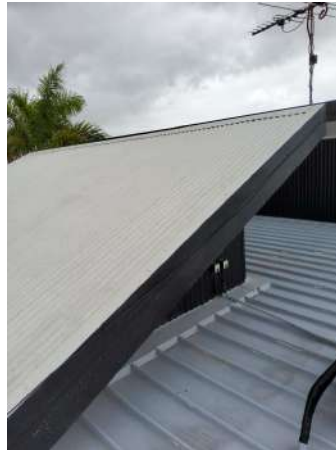
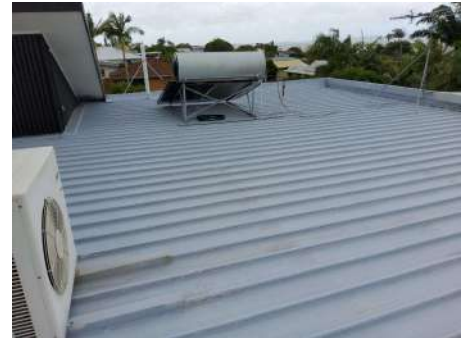
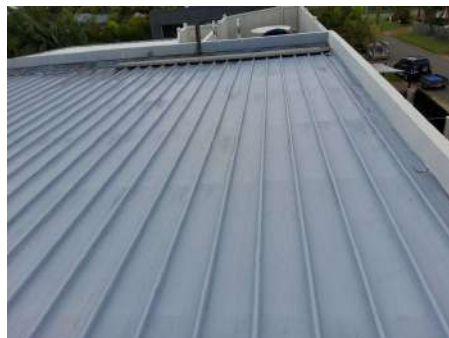
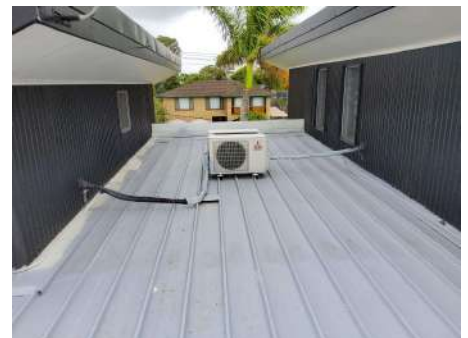
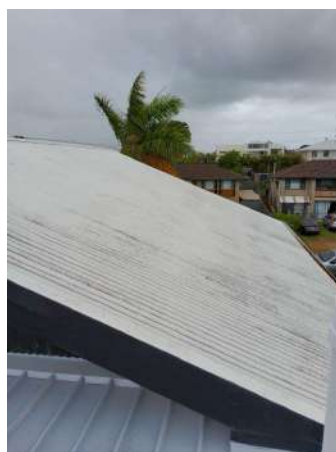
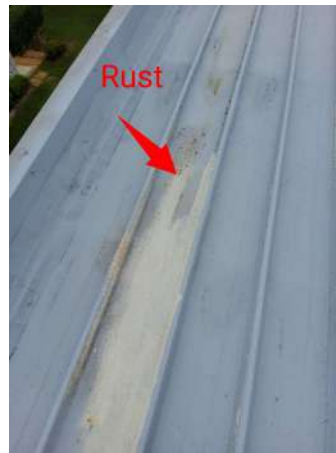
Roof Clad Condition

On inspection, defects were noted that may require further assessment and recommendations by licensed roofer.

Metal roof is rusting and requires repairs to prevent further deterioration. Ponding was also noted in sections of the roof sheeting. Contact a licensed roofing contractor for further investigation.

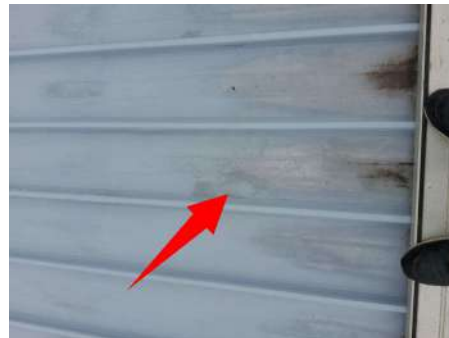
Gutter Findings

Gutter surface rust in sections- the rust is yet to penetrate and repairs/sealing may be an option. Recommendations: A qualified roof plumber should be engaged for advice and recommendations.

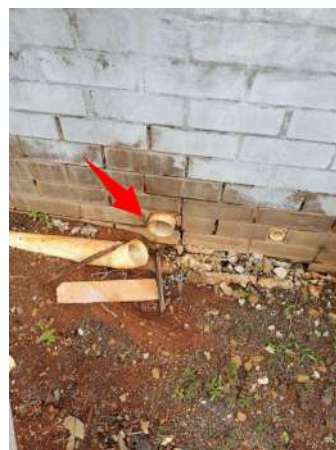
Down Pipe Findings

Down pipe/s not connected to storm water discharge - Down pipes not connected to storm water have the potential to cause differential settlement to the footings, cause rising damp and is also conducive to termite infestation. Recommendations: A qualified plumber should be engaged for advice and recommendations.

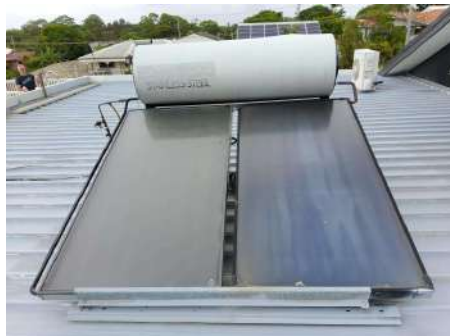
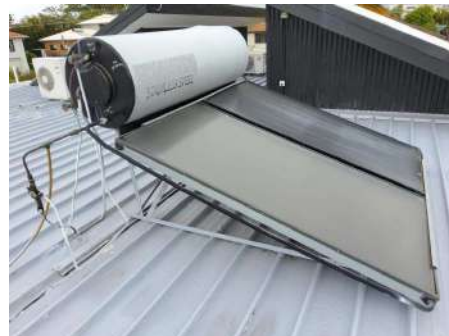
Hot Water Unit Findings

On visual inspection the hot water unit appears dilapidated. Anticipate a replacement in the not too distant future.

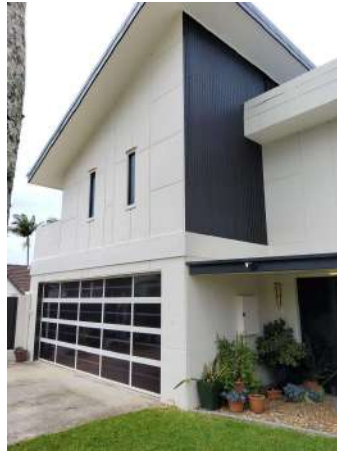
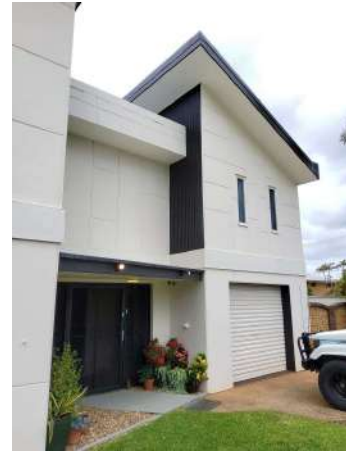
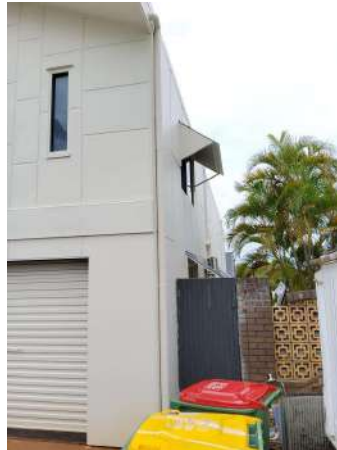
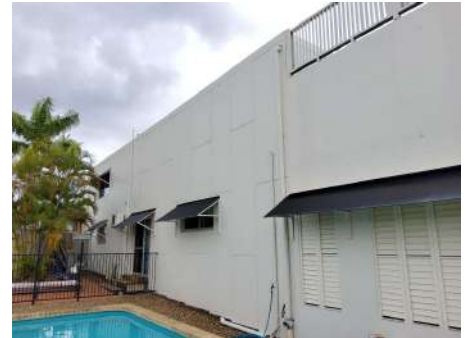
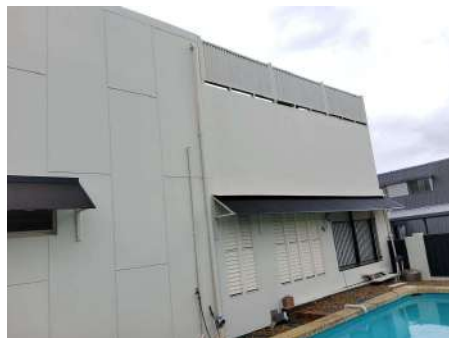
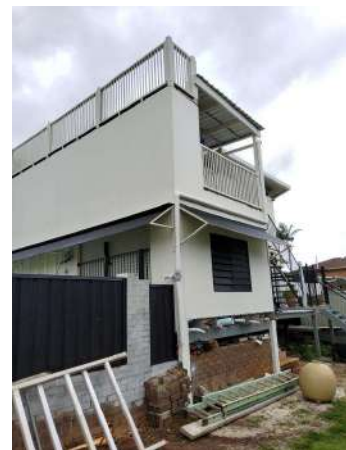
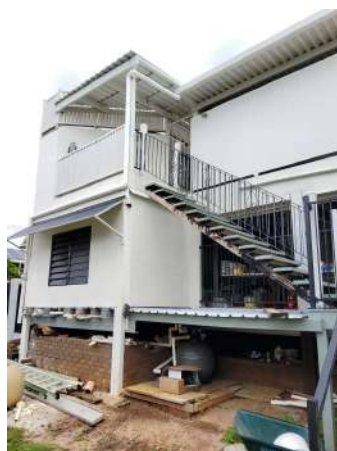
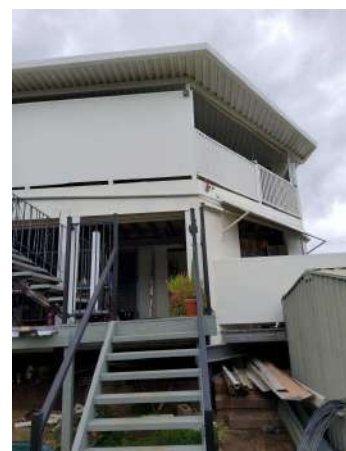
Condition

Penetration openings observed. I recommend sealing these off so as to avoid water, vermin and other pest infestation.

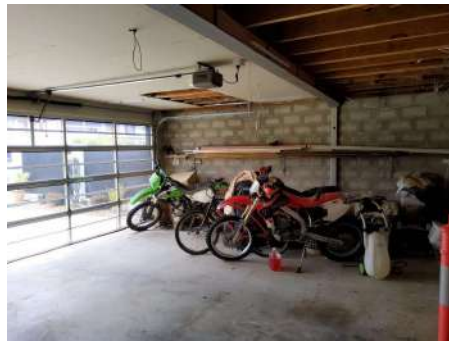
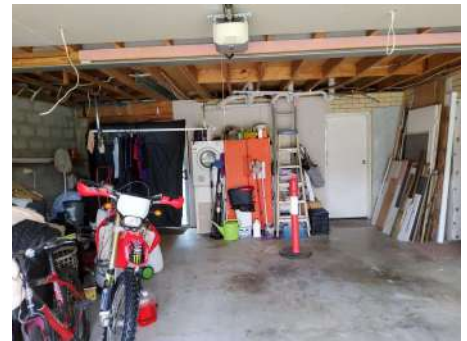
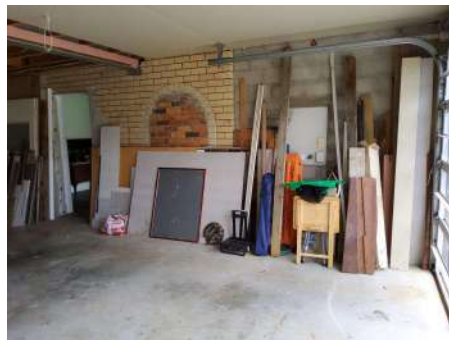
Storage items restricted a full and thorough inspection of this area. Defects may exist in the inaccessible areas. It is strongly recommended that full access be granted to enable a thorough inspection as there may be timber pest activity, damage or defects. Note: Where vehicles and storage has restricted a full inspection it is advised that this area be cleared so a full and unobstructed inspection can be carried out.

On inspection, defects were present that will require further assessing and recommendations by licensed and qualified trades persons, please read below for details. Incomplete building work noted, contact a builder for rectifications.

Exposed electrical cables noted. Contact a licensed electrician for rectifications immediately.

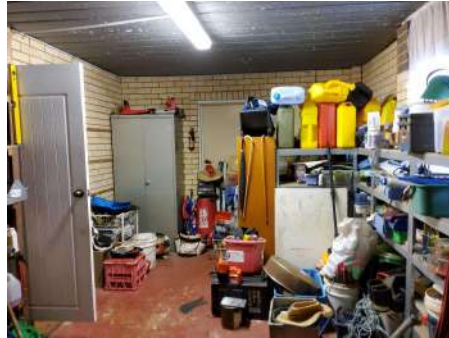
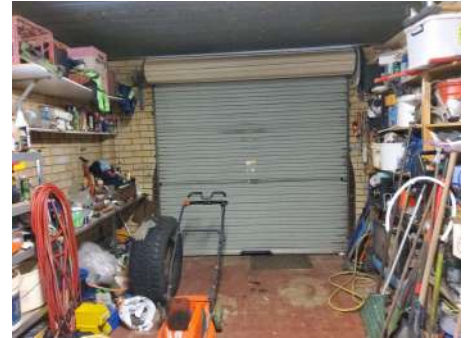
Storage items restricted a full and thorough inspection of this area. Defects may exist in the inaccessible areas. It is strongly recommended that full access be granted to enable a thorough inspection as there may be timber pest activity, damage or defects. Note: Where vehicles and storage has restricted a full inspection it is advised that this area be cleared so a full and unobstructed inspection can be carried out.

On inspection, defects were present that will require further assessing and recommendations by licensed and qualified trades persons, please read below for details. Incomplete building work noted, contact a builder for rectifications.

Exposed electrical cables noted. Contact a licensed electrician for repairs immediately.

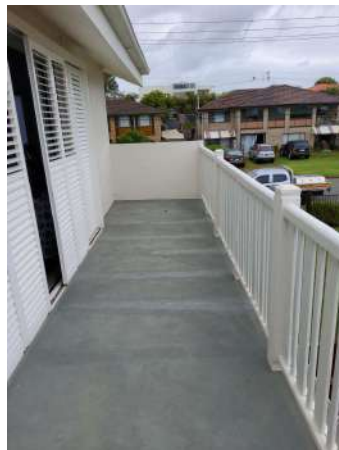
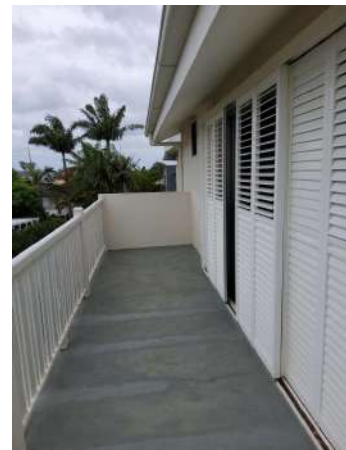
Flooring

On inspection, defects were present that will require further assessing and recommendations by licensed and qualified trades persons, please read below for details.

The floor sheeting has cracks, contact a licensed builder or waterproofing specialist for repairs.

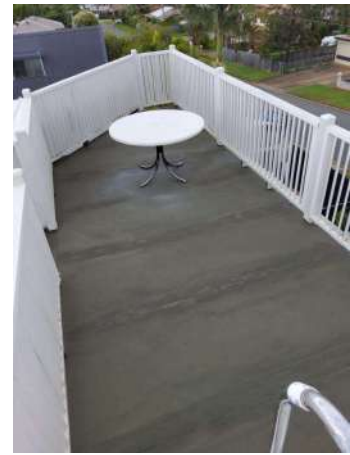
Balustrade Condition

On inspection, defects were present that will require further assessing and recommendations by licensed and qualified trades persons, please read below for details.

General age deterioration to balustrade and/or posts/rails.
Recommendations: Have assessed by a carpenter.

Leaking has occurred through flooring. Recommendations: A qualified builder should be engaged for advice and recommendations. Balcony leaking is one of the largest complaints received by the building commission and rectification can involve removing all flooring and adequate damp proofing works carried out.

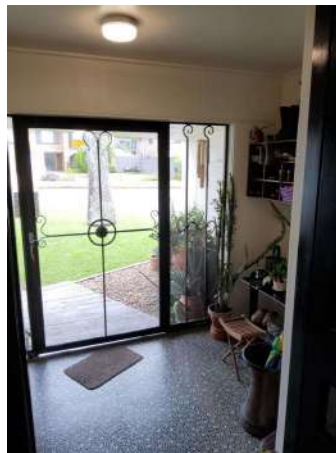
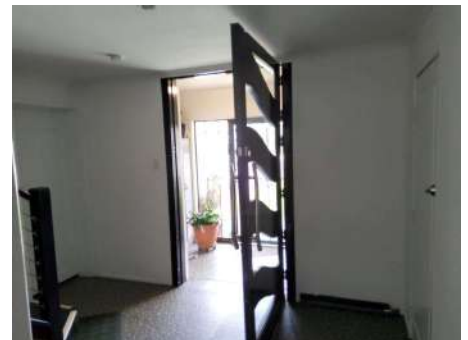
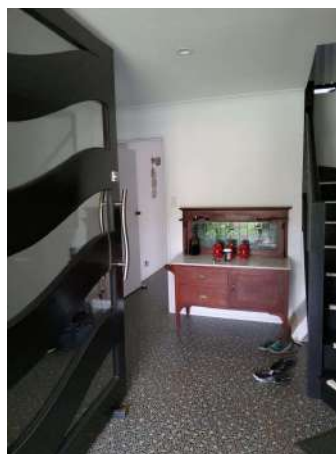
From the visible and accessible areas, the entry/Hallways appears to be in a serviceable condition for the age of the property with no notable structural defects sighted.

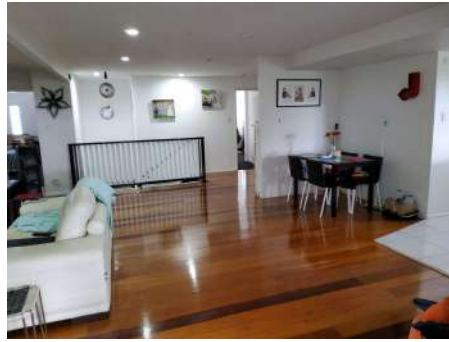
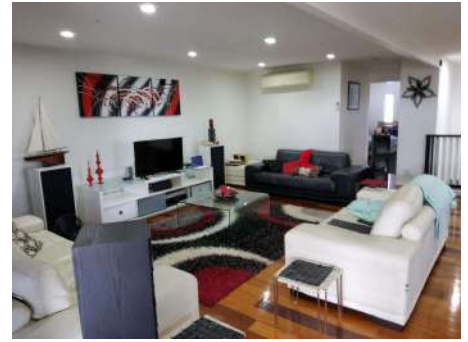
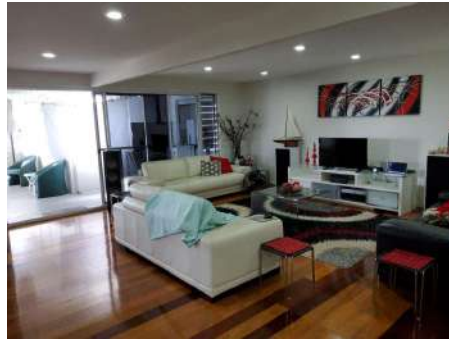
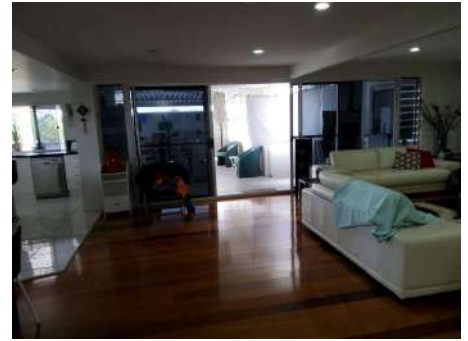
From the visible and accessible areas, the lounge room appears to be in a serviceable condition for the age of the property with no notable structural defects sighted.

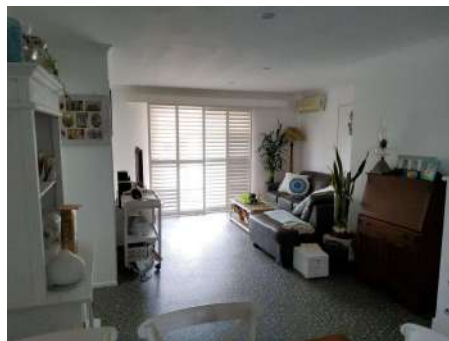
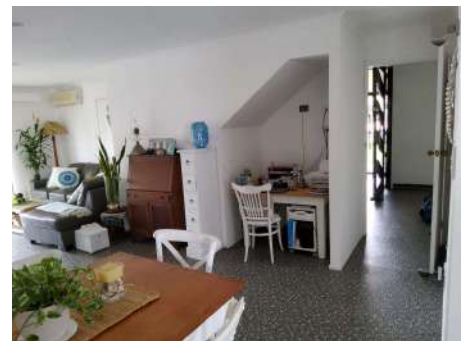
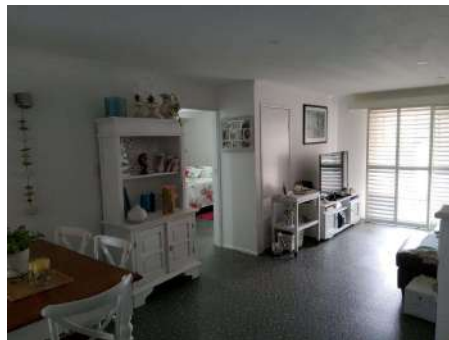
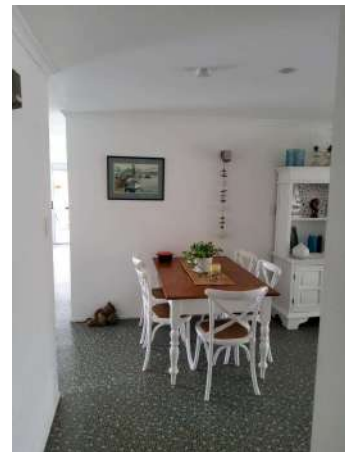
Combo Lounge & Dining Room

From the visible and accessible areas, the lounge and dining room appears to be in a serviceable condition for the age of the property with no notable structural defects sighted.

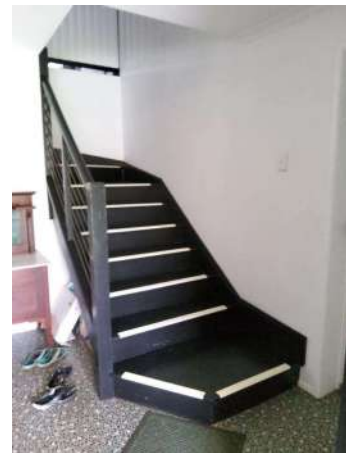
The internal stair case is in a serviceable condition for the age with no notable defects sighted.

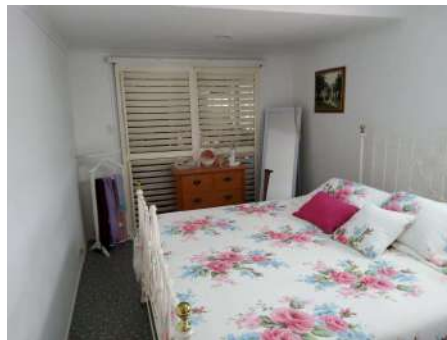
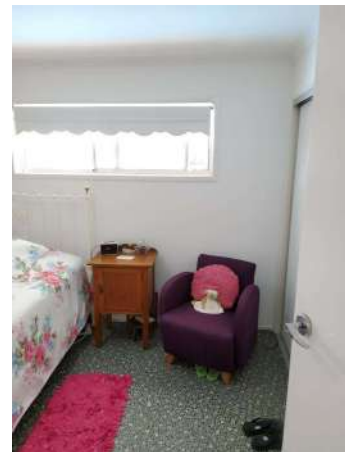
Bedroom 1

This bedroom is in serviceable condition for the age with no notable structural defects sighted.

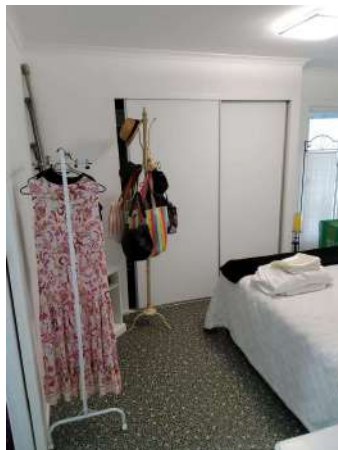
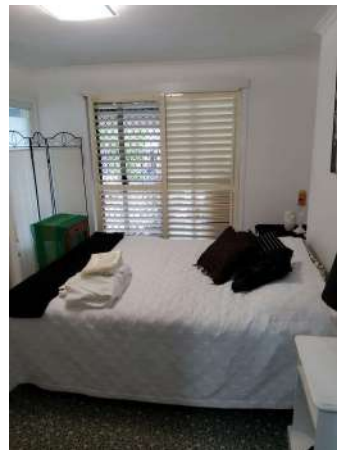
Bedroom 2

This bedroom is in serviceable condition for the age with no notable structural defects sighted.

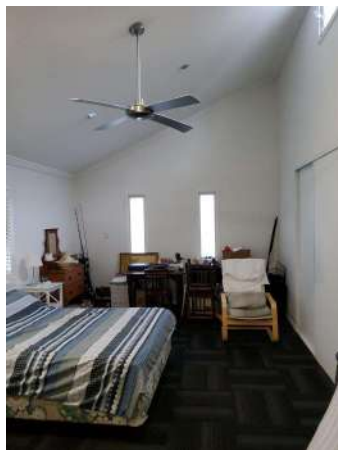
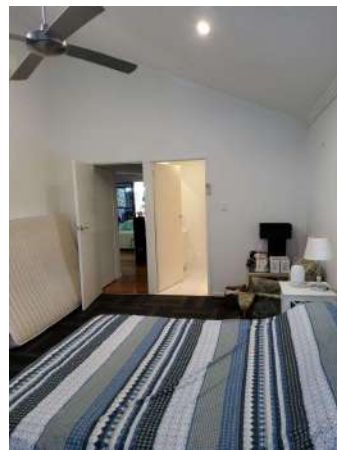
Bedroom 3

This bedroom is in serviceable condition for the age with no notable structural defects sighted.

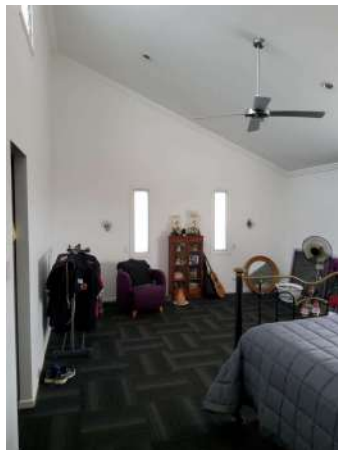
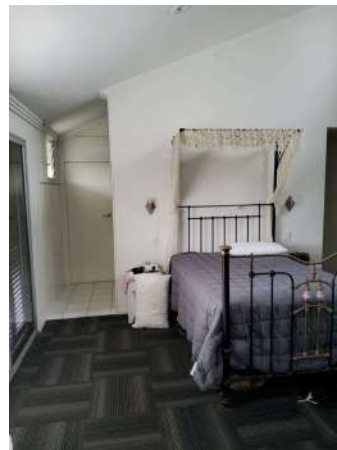
Bedroom 4

This bedroom is in serviceable condition for the age with no notable structural defects sighted.

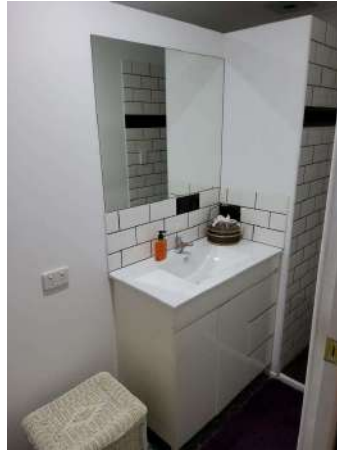
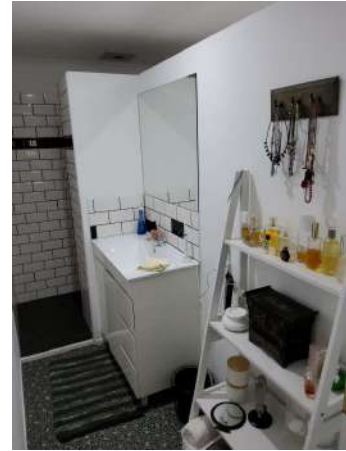
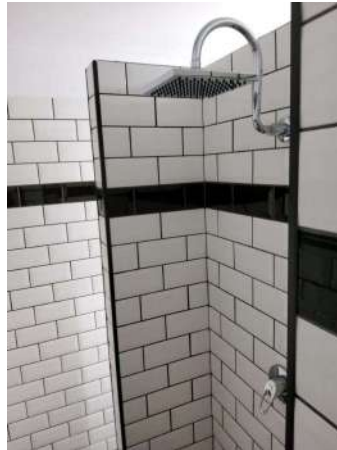
Bathroom 1

This bathroom is located downstairs

Of the visible areas, the general condition of this bathroom is serviceable or in reasonable condition for age of dwelling.

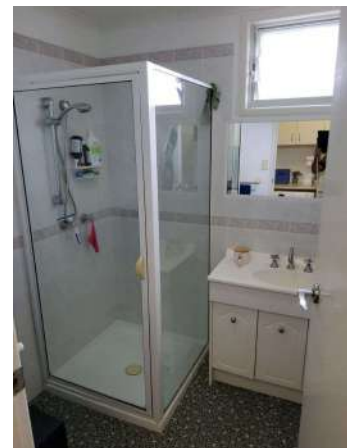
This bathroom is located downstairs

Of the visible areas, the general condition of this bathroom is serviceable or in reasonable condition for age of dwelling.

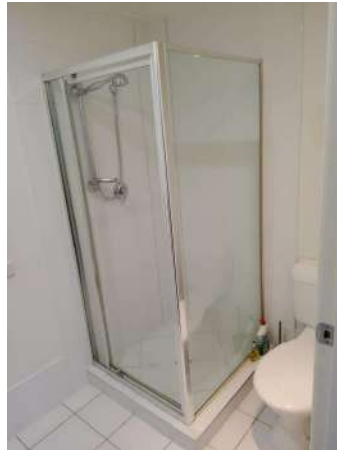
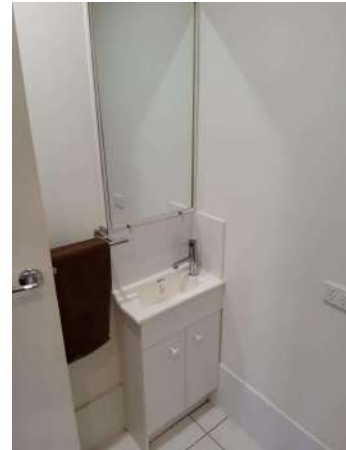
This bathroom is located in the bedroom
This bathroom is located upstairs

Of the visible areas, the general condition of this bathroom is serviceable or in reasonable condition for age of dwelling.

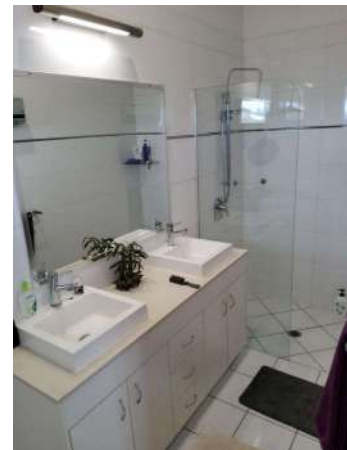
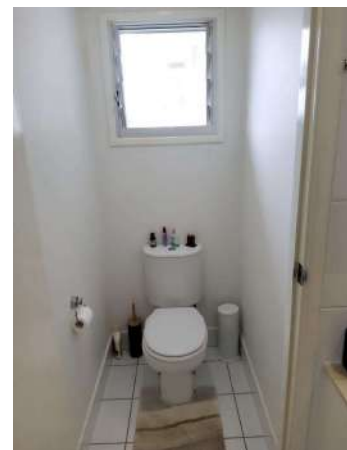
This bathroom is located in the master bedroom

Of the visible areas, the general condition of this bathroom is serviceable or in reasonable condition for age of dwelling.

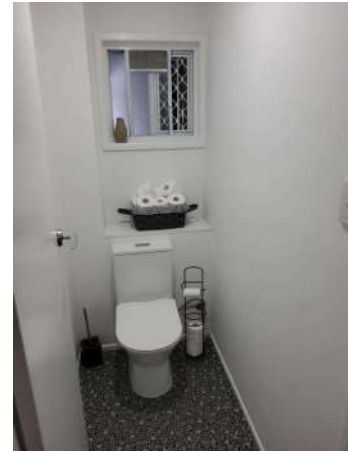
Toilet 1

Of the visible areas, the general condition of the Toilet is serviceable or in reasonable condition for age of dwelling.

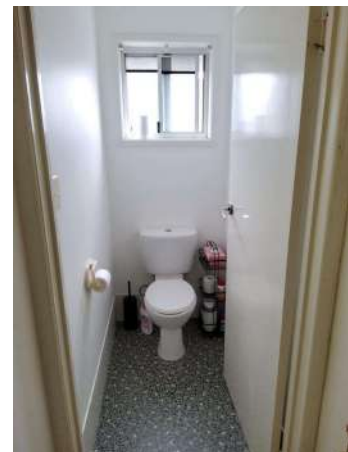
On inspection, defects were present that will require further assessing and recommendations by licensed and qualified trades persons, please read below for details.

The seal is deteriorated where leaking can occur. Contact a licensed plumber for replacement.

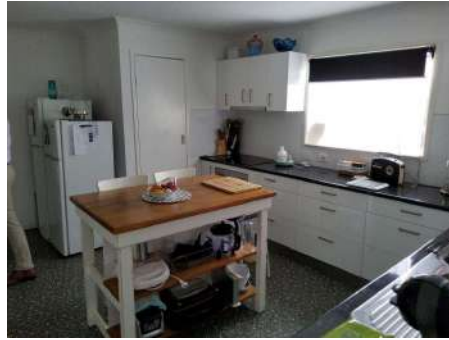
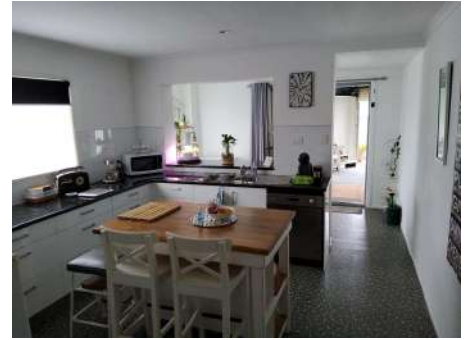
Of the visible areas, the general condition of the kitchen is serviceable or in reasonable condition for age of dwelling.

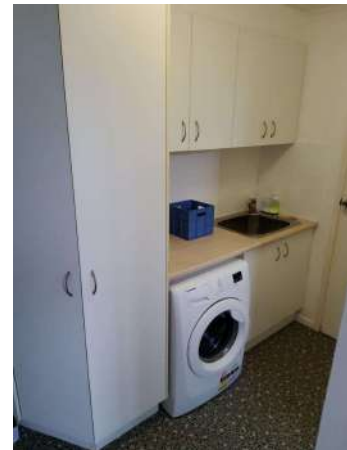
Of the visible areas, the general condition of the laundry is serviceable.

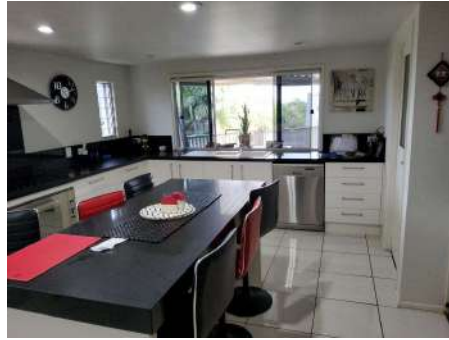
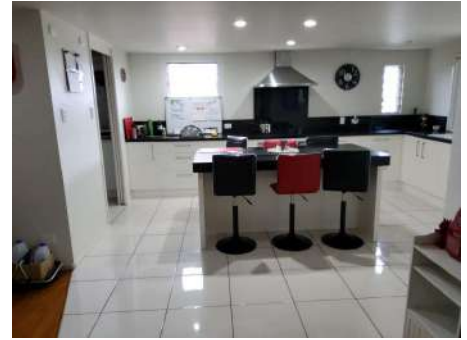
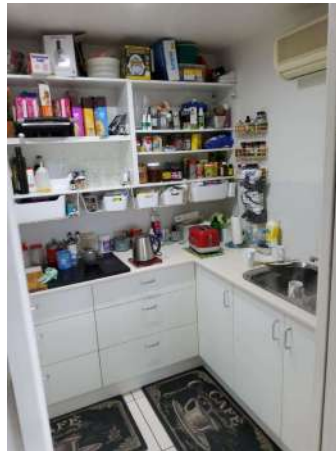
Of the visible areas, the general condition of the kitchen is serviceable or in reasonable condition for age of dwelling.

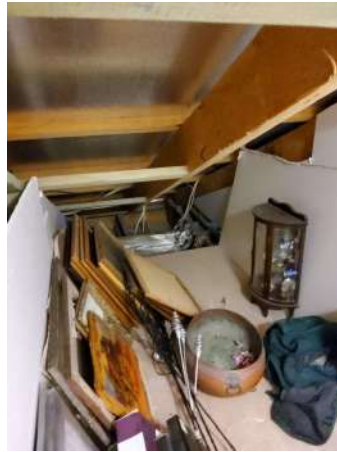
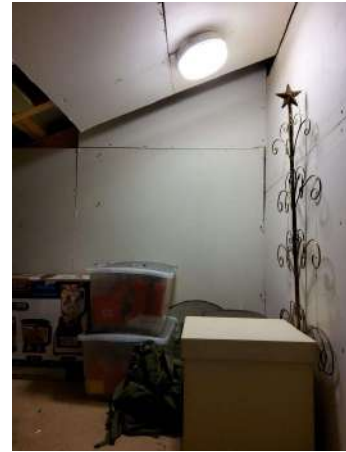
Roof void has been converted to attic storage. Visual inspection not possible due to boards being placed on ceiling joists

Cathedral ceiling design - No crawl space. It is strongly recommended that full access be gained as it could be harbouring timber pest activity, damage or defects.

Flat / Skillion Roof - There is no crawl space in a flat roof design.

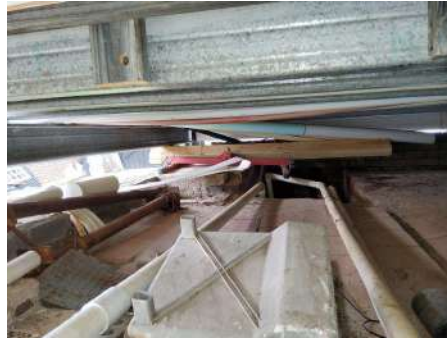
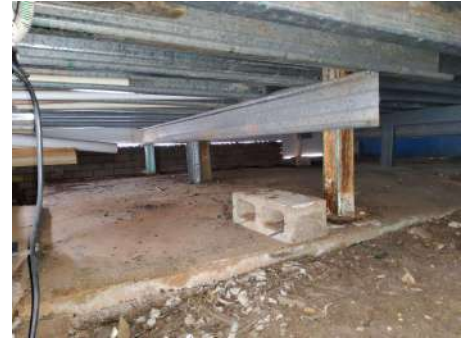
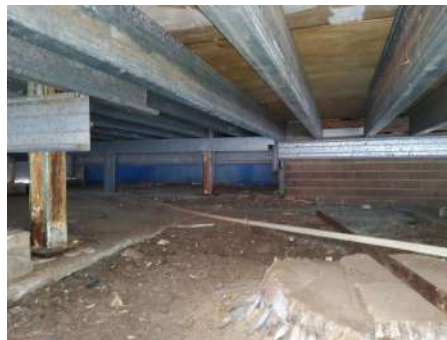
On inspection, defects were present that will require further assessing and recommendations by licensed and qualified trades persons, for example, a structural engineer, plumber, carpenter, electrician, plasterer may need to assess. Please read below for details.

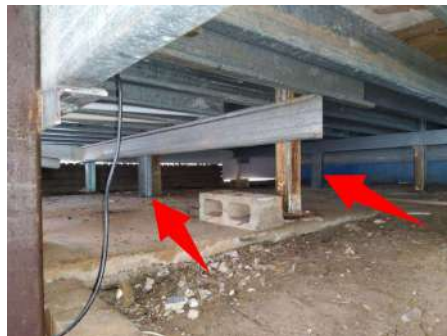
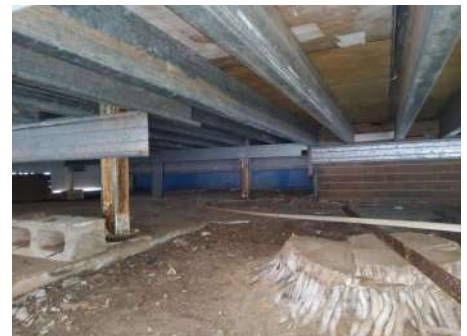
Rust is evident in the post / posts supporting the house. This must be treated to prevent further deterioration of materials.

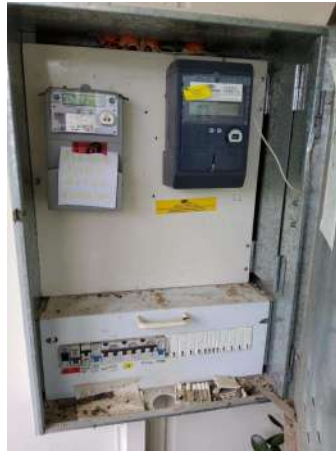
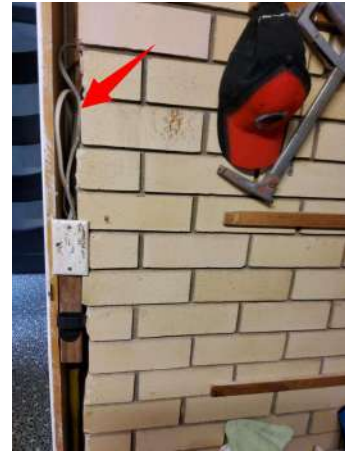
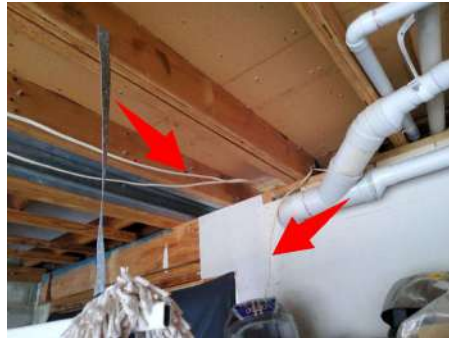
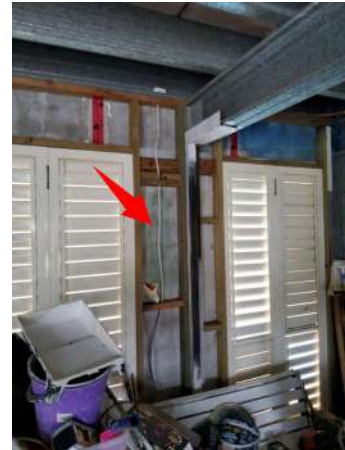
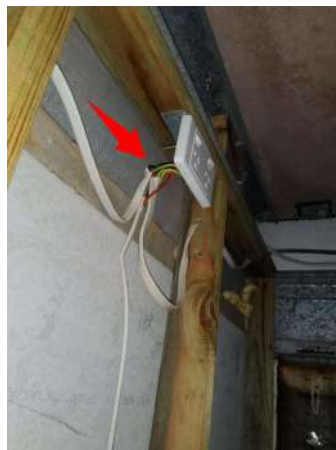
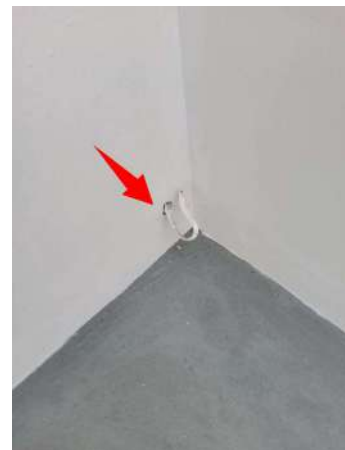
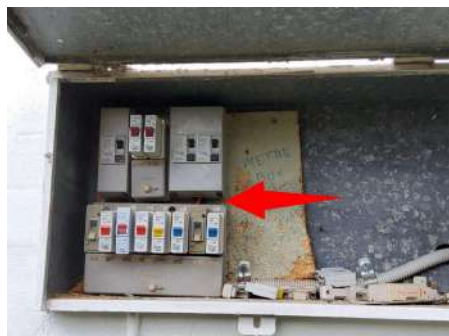
Electricity to the dwelling was connected. Note: We do not carry out electrical inspections for wiring or safety. This must be carried out by a licensed electrician and I recommend you have all electrical wiring and components assessed by a licensed electrician. Exposed electrical cables noted. Recommendation engage a qualified electrician to make safe immediately.
